ON SITE DIAGNOSIS AND ASSESSMENT OF THE NAVE TIMBER STRUCTURE OF SEGOVIA CATHEDRAL (SPAIN) USING NON DESTRUCTIVE TECHNIQUES

Basterra, L.A. (1), López, G. (1), Ramón-Cueto, G. (1), Acuña, L. (2) and Casado, M. (2)

Abstract

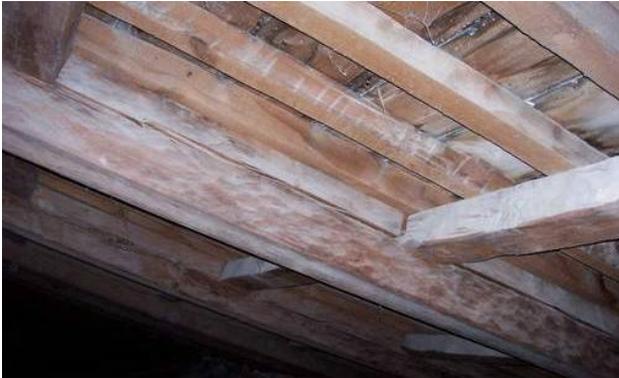
The defects most frequently encountered are knots and wane. These are found mainly in the rafter ties due to their large section. The knots are of great importance for the timbers mechanical strength, while the waning simply constitutes a reduction in the overall section of the timber. It is also quite common to find splitting that took place in the drying process and may appear down the entire length of the timber.

Figure 8. Longitudinal splitting in the rafter.

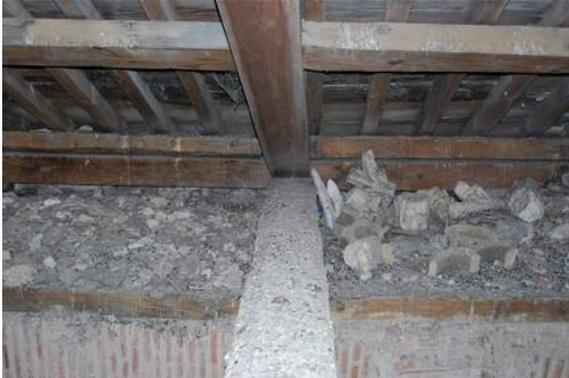
Figure 9. Waning on rafter tie.

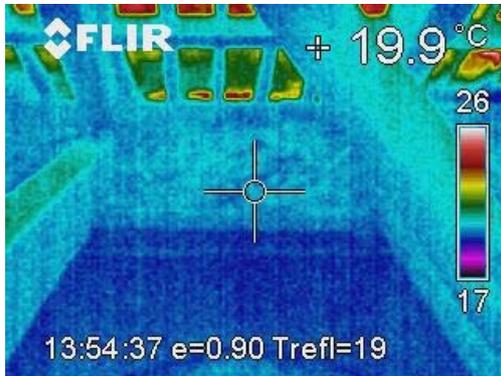
Figure 10. Uniform temperature detected in dry zones.

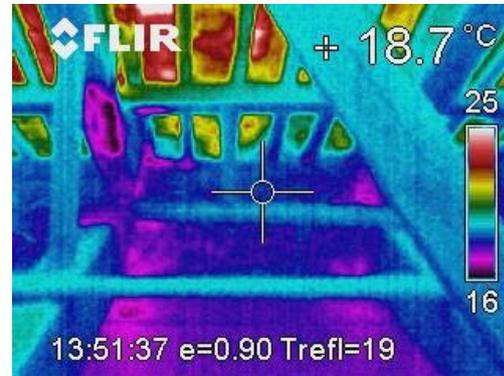
The non-biological pathologies are due mainly to the humidity caused by leaks usually found on the north facing side of the roof. In the most affected areas, the moisture has passed through the planking to the rafters and down through to the sill plate and walls.

In the area where the trusses come into contact with the wall there are also humid areas but, because access was not possible, a quantitative determination was not possible to be

made with the xilohigrometer. In these areas, an infrared thermographic camera was used in order to get images that can be very useful to quantify the areas that had moisture present at the time of the inspection.

Figure 11. Localizing humidity by infrared thermography.

As a general rule, all humid or wet areas should be eliminated. The accumulated debris, which makes adequate ventilation impossible, should also be removed.

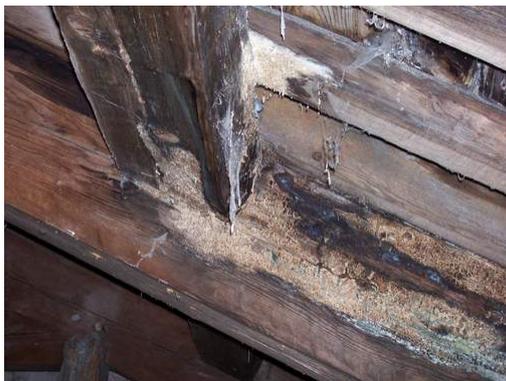
It should be noted that, in general, the state of the timbers in the roof structure is quite good. There appears to be limited biological pathologies with practically an absence of insect attacks except in small areas that were found to be, in most cases, of little depth. The biological pathologies present were in the form of wood destroying fungus, which only in exceptional cases has caused damage to some truss elements.

Figure 12. Advanced fungi decay.

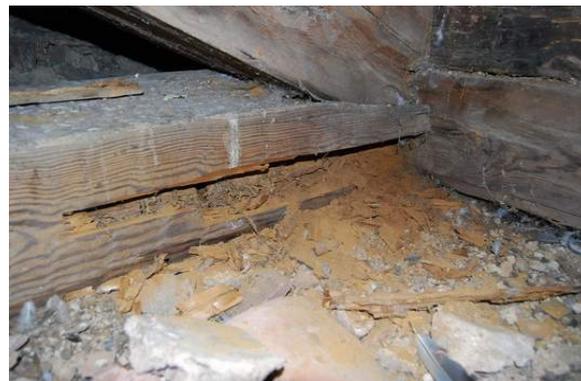
Figure 13. Deep damage caused by insects in the rafter ties.

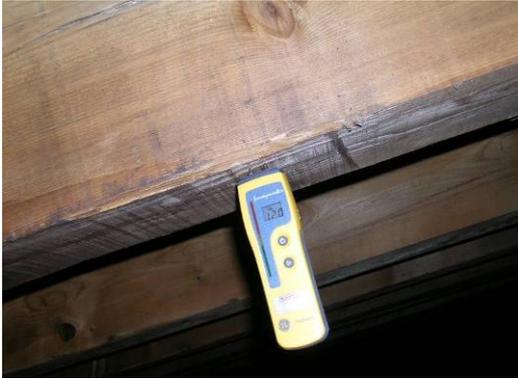
In our case, the moisture content of the wood tested had an average humidity value of between 10 and 15%, which is considered normal for timber in a roof structure. However, there are areas where, due to rainwater leaks, high moisture content, in excess of 17%, was found. These high readings can be compared directly with the thermographic images taken, which reflect the distribution of humidity in each timber element.

Figure 16. Humidity reading with electric xilohigrometer.

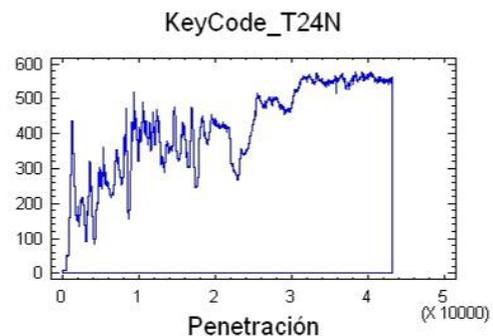
Figure 19. Resistogram data.

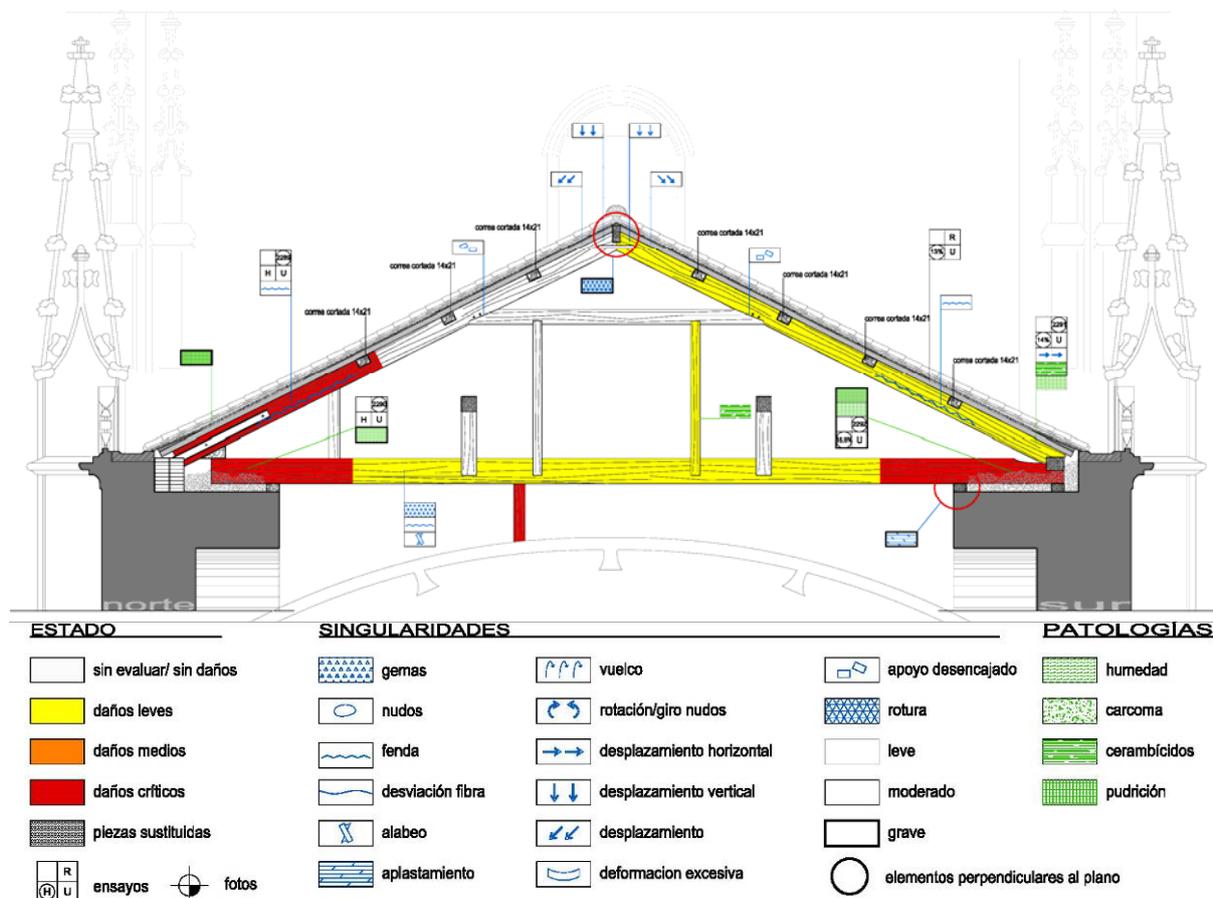
Figure 11: Graphic representation of results.

As we can see, Figure 11 consists of a hyper textual document based on a series of icons that assist in navigating through photographs and results of the trials and tests conducted. In addition colours are used to indicate in an immediate way the severity of the damage that has been discovered.
