SACoMaTiS 2008

International RILEM Conference

ON SITE DIAGNOSIS AND ASSESSMENT OF THE NAVE TIMBER STRUCTURE OF SEGOVIA CATHEDRAL (SPAIN) USING NON DESTRUCTIVE TECHNIQUES

Basterra, L.A. (1), López, G. (1), Ramón-Cueto, G. (1), Acuña, L. (2) and Casado, M. (2)

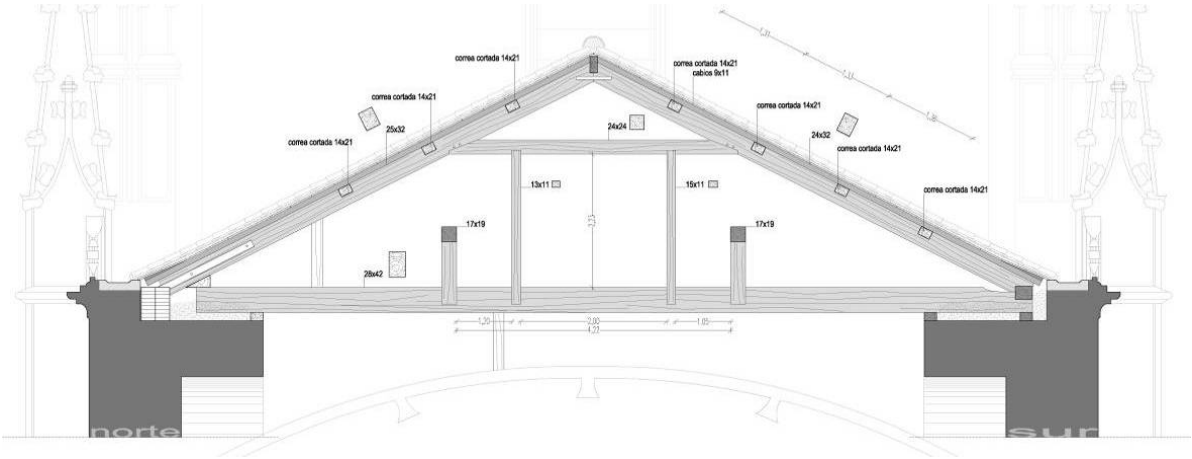
Figure 7. Typical section of main trusses.

As the walls flare at the top to almost 2 m it allows for an effective system of increasing support for the trusses, with two favourable consequences: trusses can rely on a double sill plate, with the consequent sharing of the bearing load, and the free span is reduced from 14,30 to 11,10 m (Figure 7).

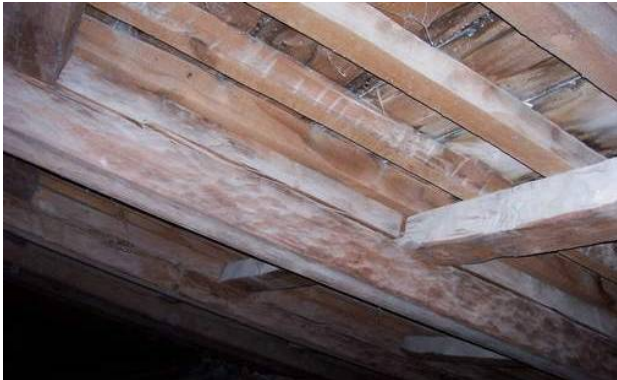
The defects most frequently encountered are knots and wane. These are found mainly in the rafter ties due to their large section. The knots are of great importance for the timbers mechanical strength, while the waning simply constitutes a reduction in the overall section of the timber. It is also quite common to find splitting that took place in the drying process and may appear down the entire length of the timber.

Figure 8. Longitudinal splitting in the rafter.

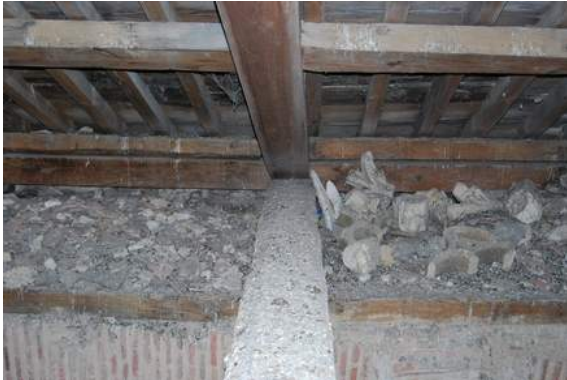
Figure 9. Waning on rafter tie.

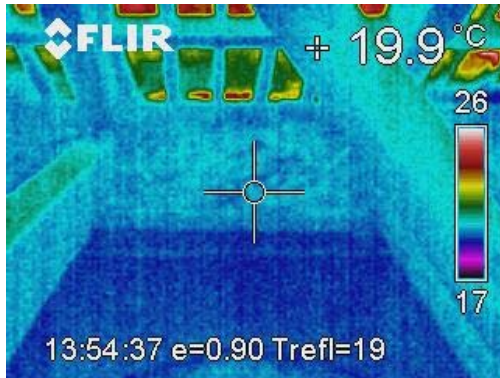
Figure 10. Uniform temperature detected in dry zones.

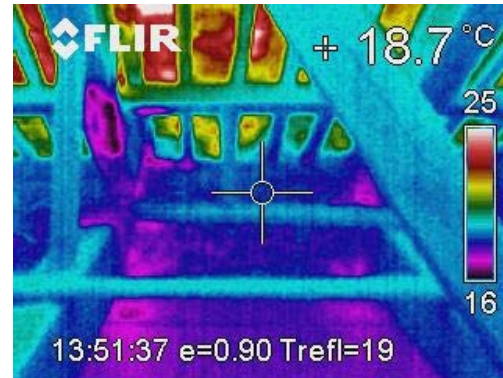
The non-biological pathologies are due mainly to the humidity caused by leaks usually found on the north facing side of the roof. In the most affected areas, the moisture has passed through the planking to the rafters and down through to the sill plate and walls.

Figure 11. Localizing humidity by infrared thermography.

In our case, the moisture content of the wood tested had an average humidity value of between 10 and 15%, which is considered normal for timber in a roof structure. However, there are areas where, due to rainwater leaks, high moisture content, in excess of 17%, was found. These high readings can be compared directly with the thermographic images taken, which reflect the distribution of humidity in each timber element.

As a general rule, all humid or wet areas should be eliminated. The accumulated debris, which makes adequate ventilation impossible, should also be removed.

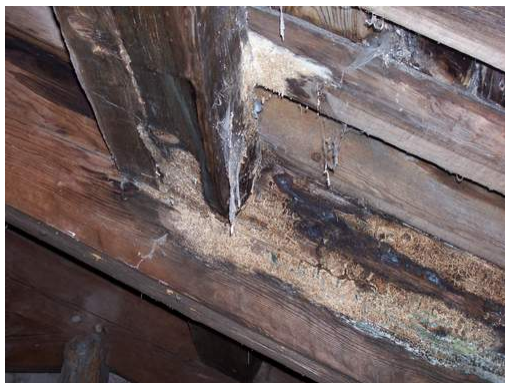
It should be noted that, in general, the state of the timbers in the roof structure is quite good. There appears to be limited biological pathologies with practically an absence of insect attacks except in small areas that were found to be, in most cases, of little depth. The biological pathologies present were in the form of wood destroying fungus, which only in exceptional cases has caused damage to some truss elements.

Figure 12. Advanced fungi decay.

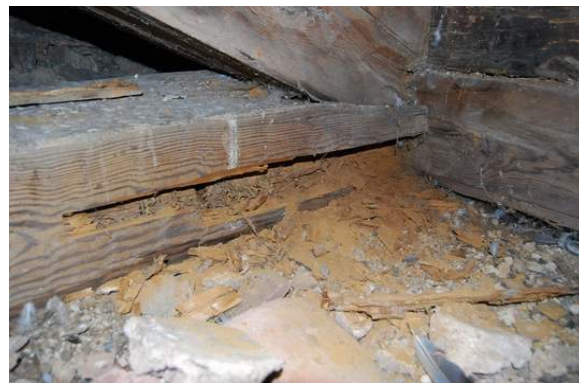
Figure 13. Deep damage caused by insects in the rafter ties.

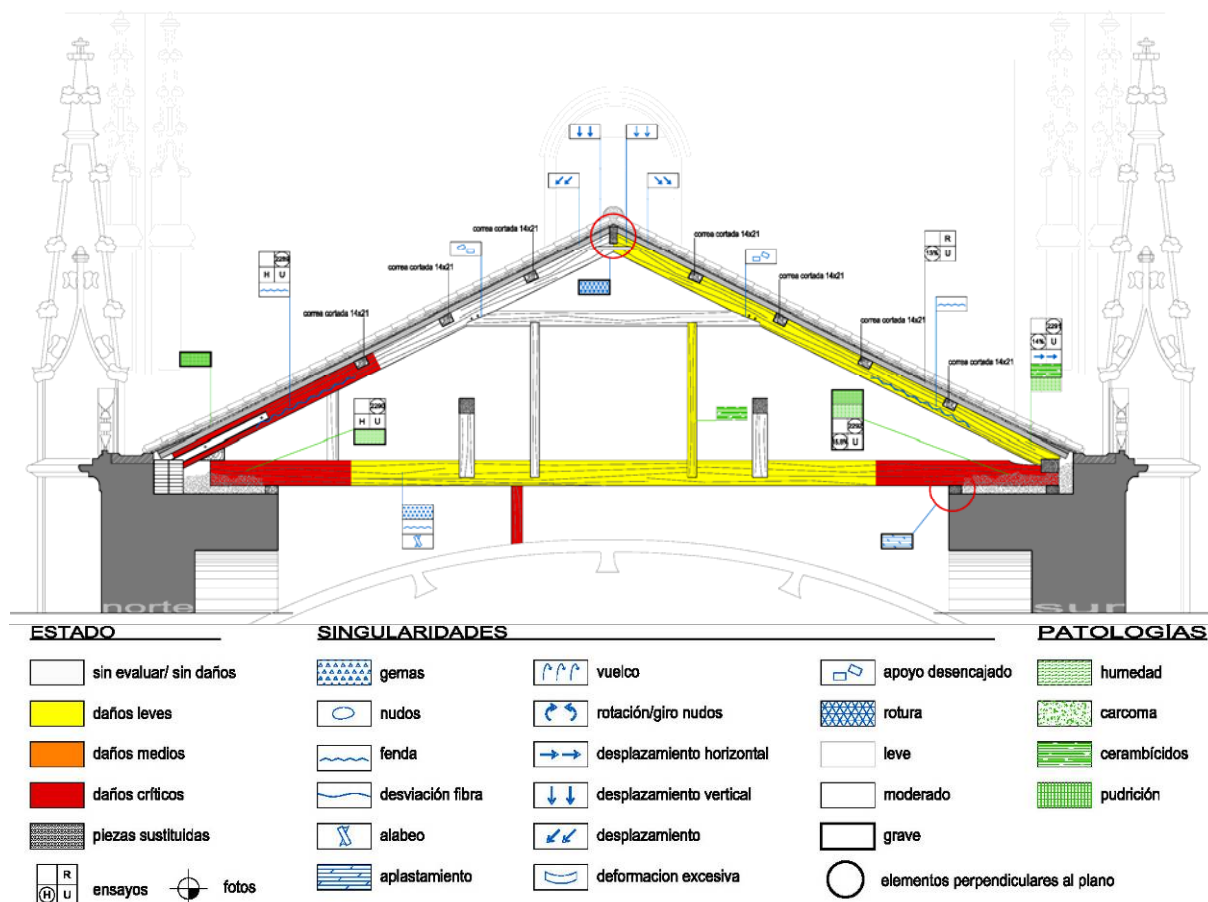
Figure 11: Graphic representation of results.

As we can see, Figure 11 consists of a hyper textual document based on a series of icons that assist in navigating through photographs and results of the trials and tests conducted. In addition colours are used to indicate in an immediate way the severity of the damage that has been discovered.
