**“From Material to Structure”
 MECHANICAL BEHAVIOUR AND FAILURES
 OF THE TIMBER STRUCTURES**

RESTORATION OF THE CHURCH ROOF OF CARTHUSIAN MONASTERY OF S^a MARIA DE MIRAFLORES, BURGOS (SPAIN)

main architect: luis-alfonso basterra
 collaborating architect: gamaliel lópez
 architectural technician: fernando gonzález
 constructor: trycsa, s.a.
 developer: Junta de Castilla y León

SPAIN, 2004-2006

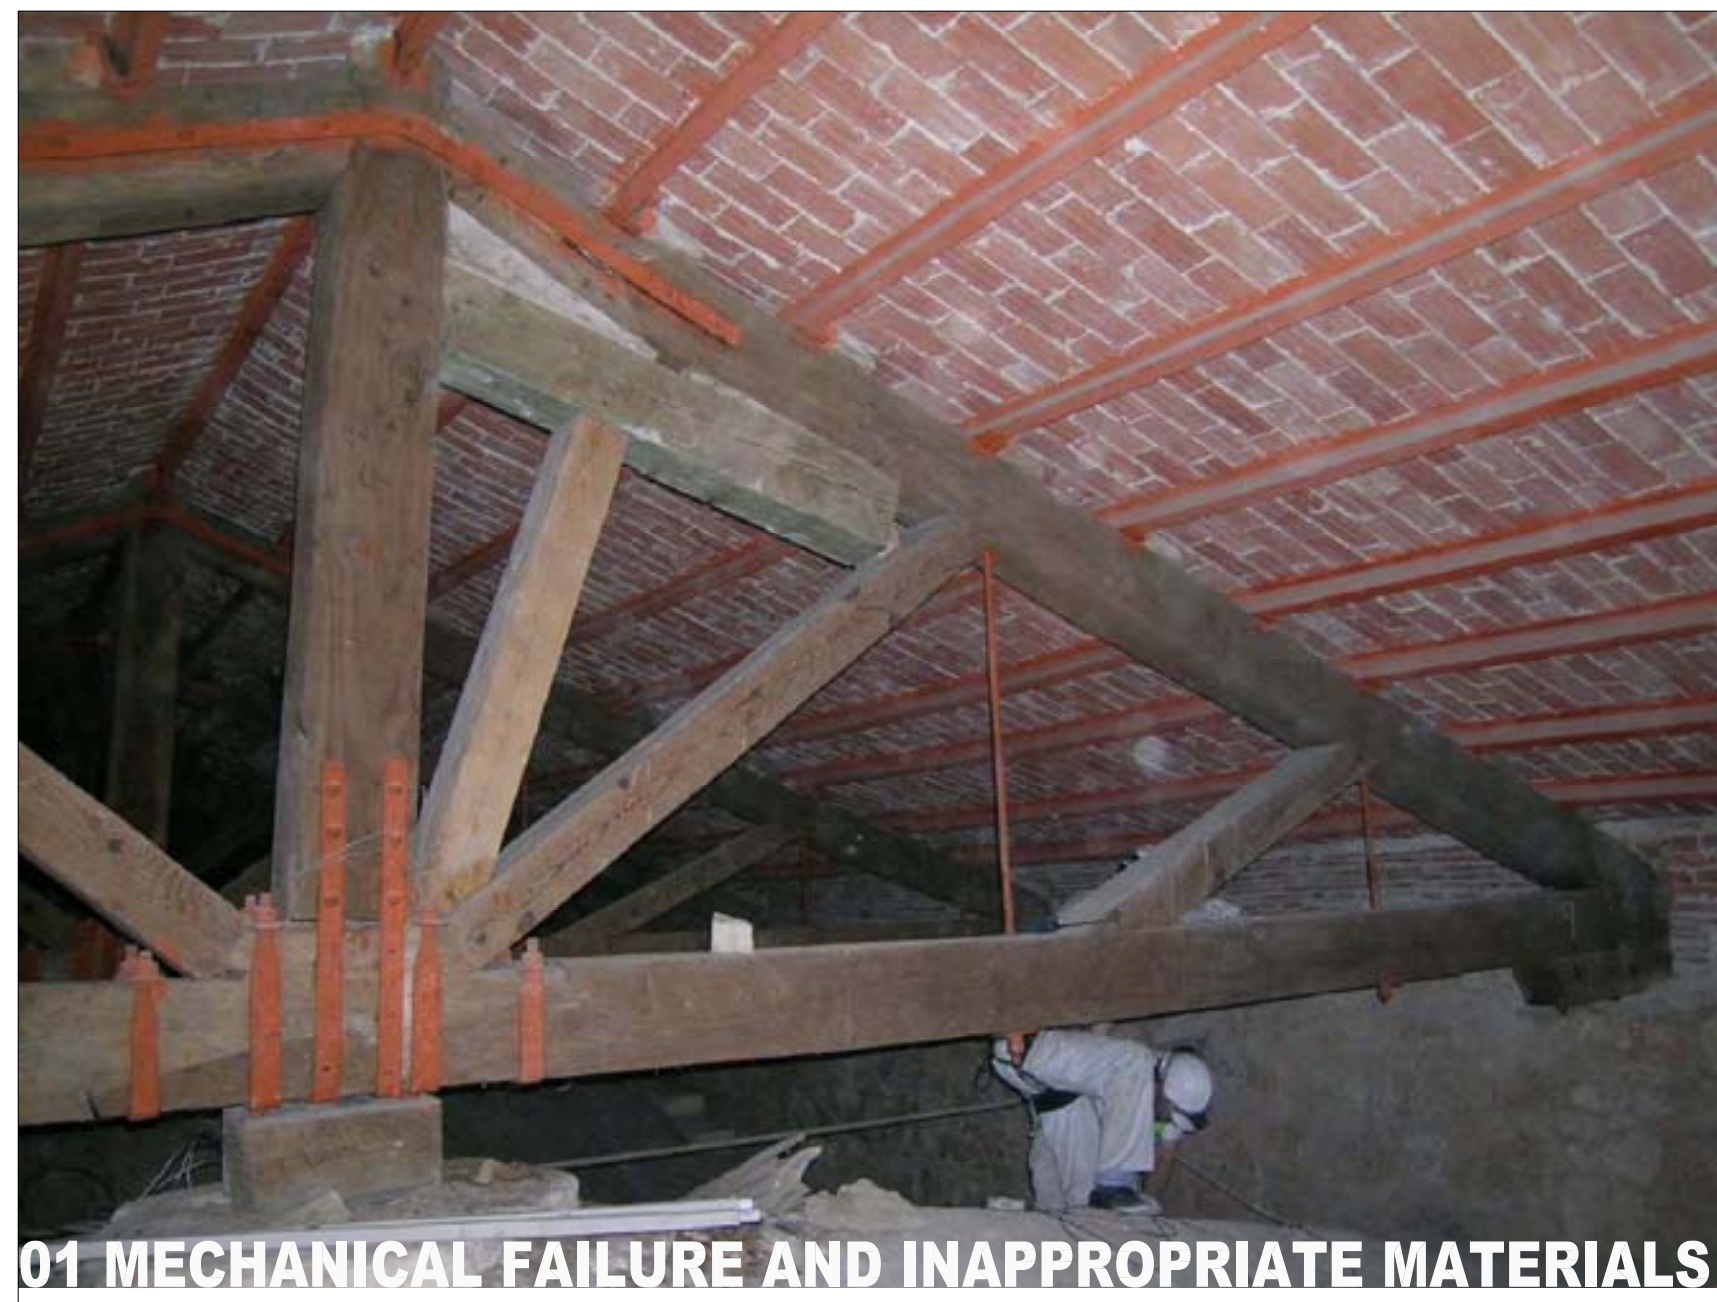
01 MECHANICAL FAILURE AND INAPPROPRIATE MATERIALS

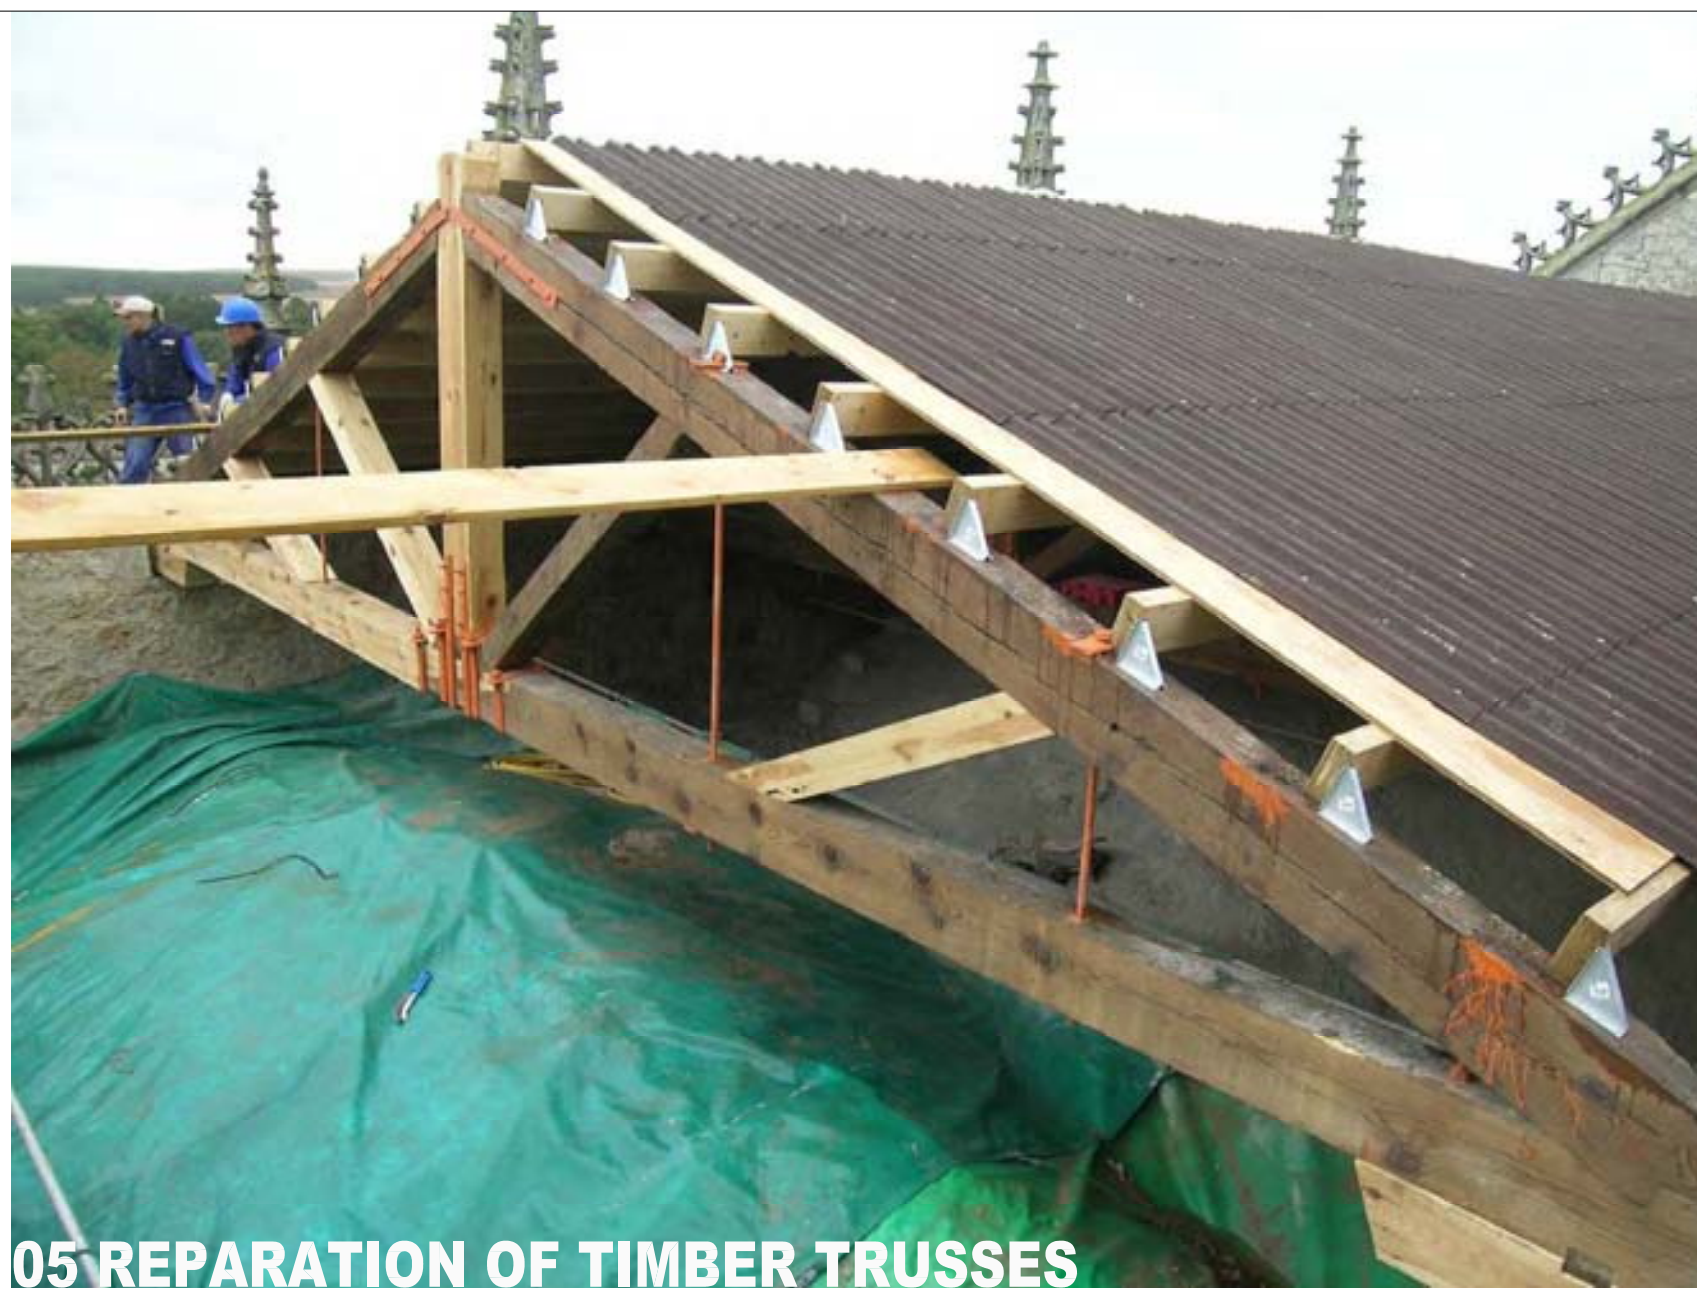
05 REPAIRATION OF TIMBER TRUSSES

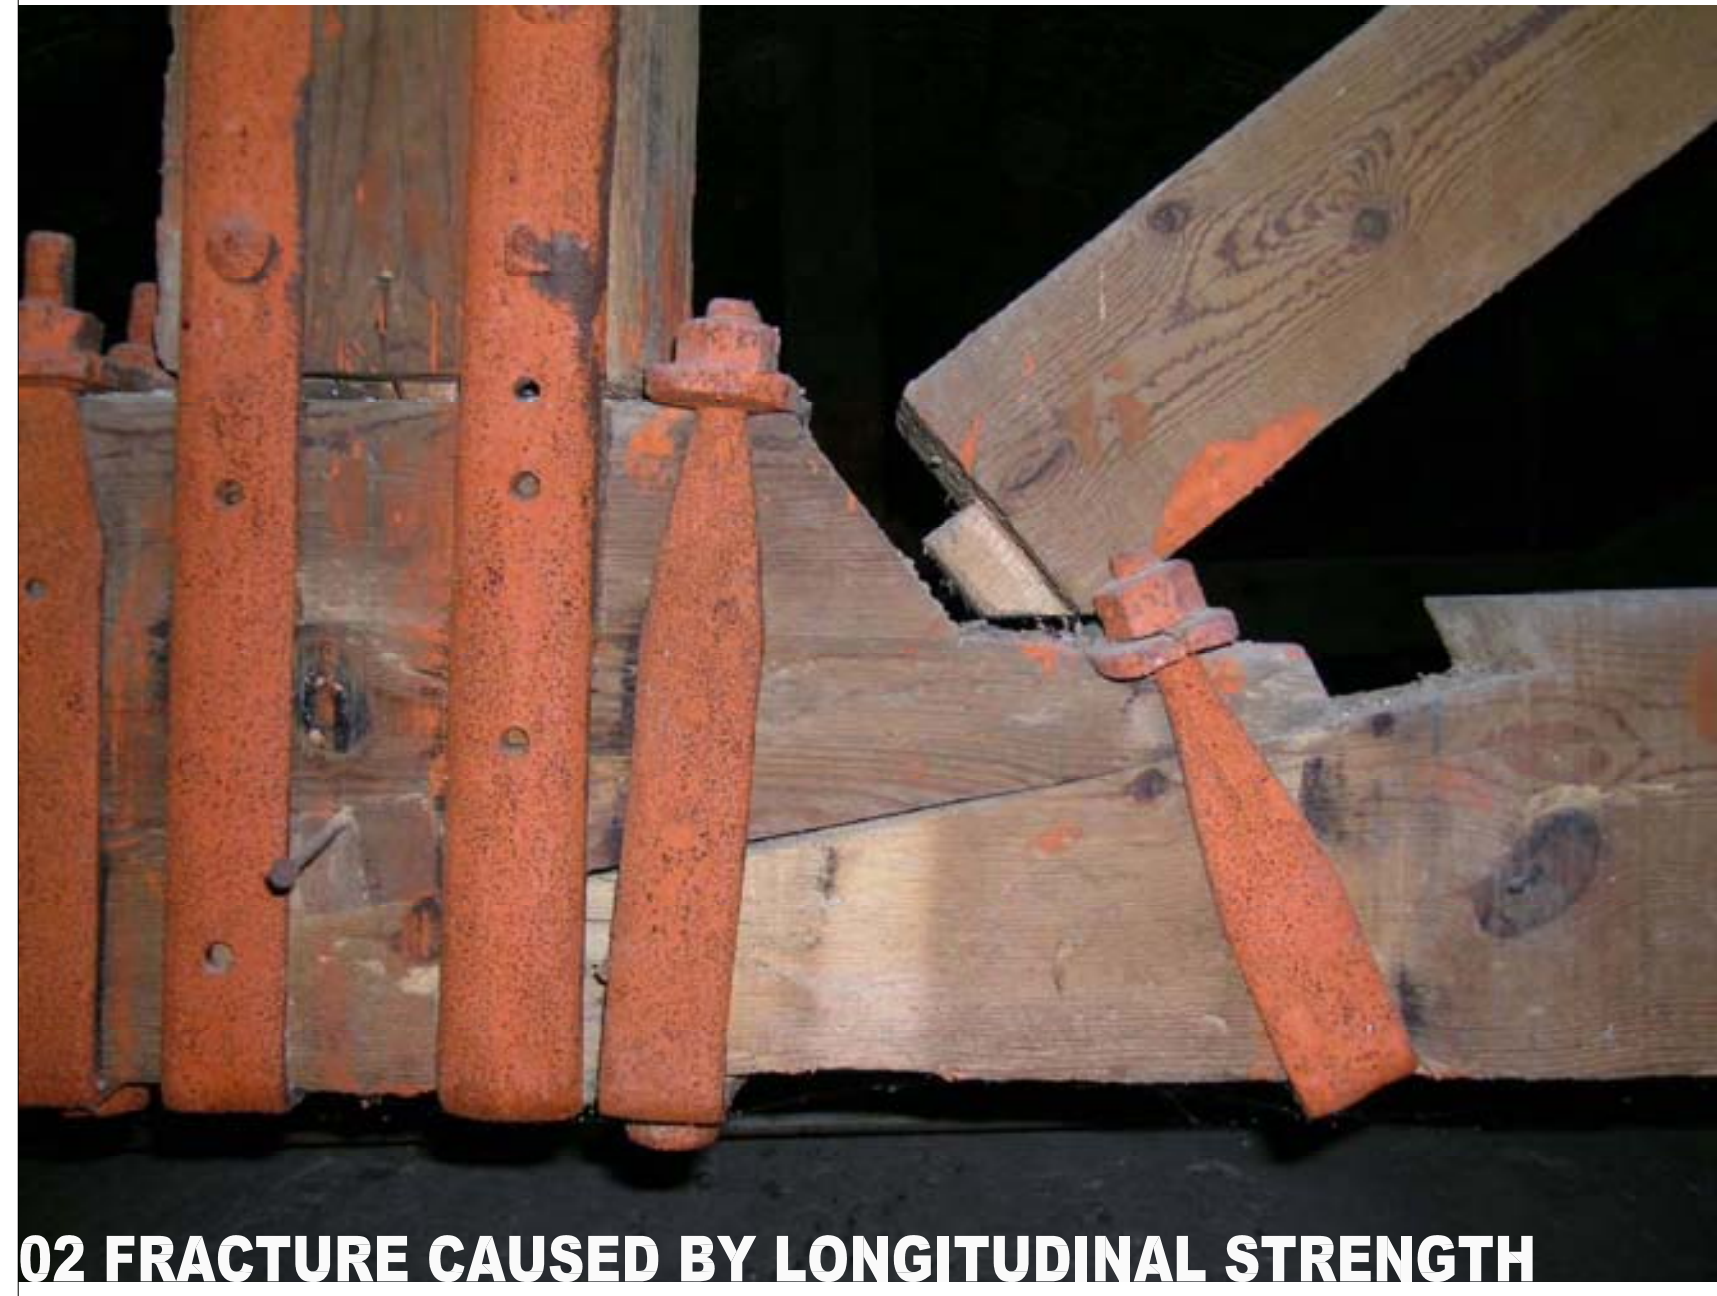
02 FRACTURE CAUSED BY LONGITUDINAL STRESS

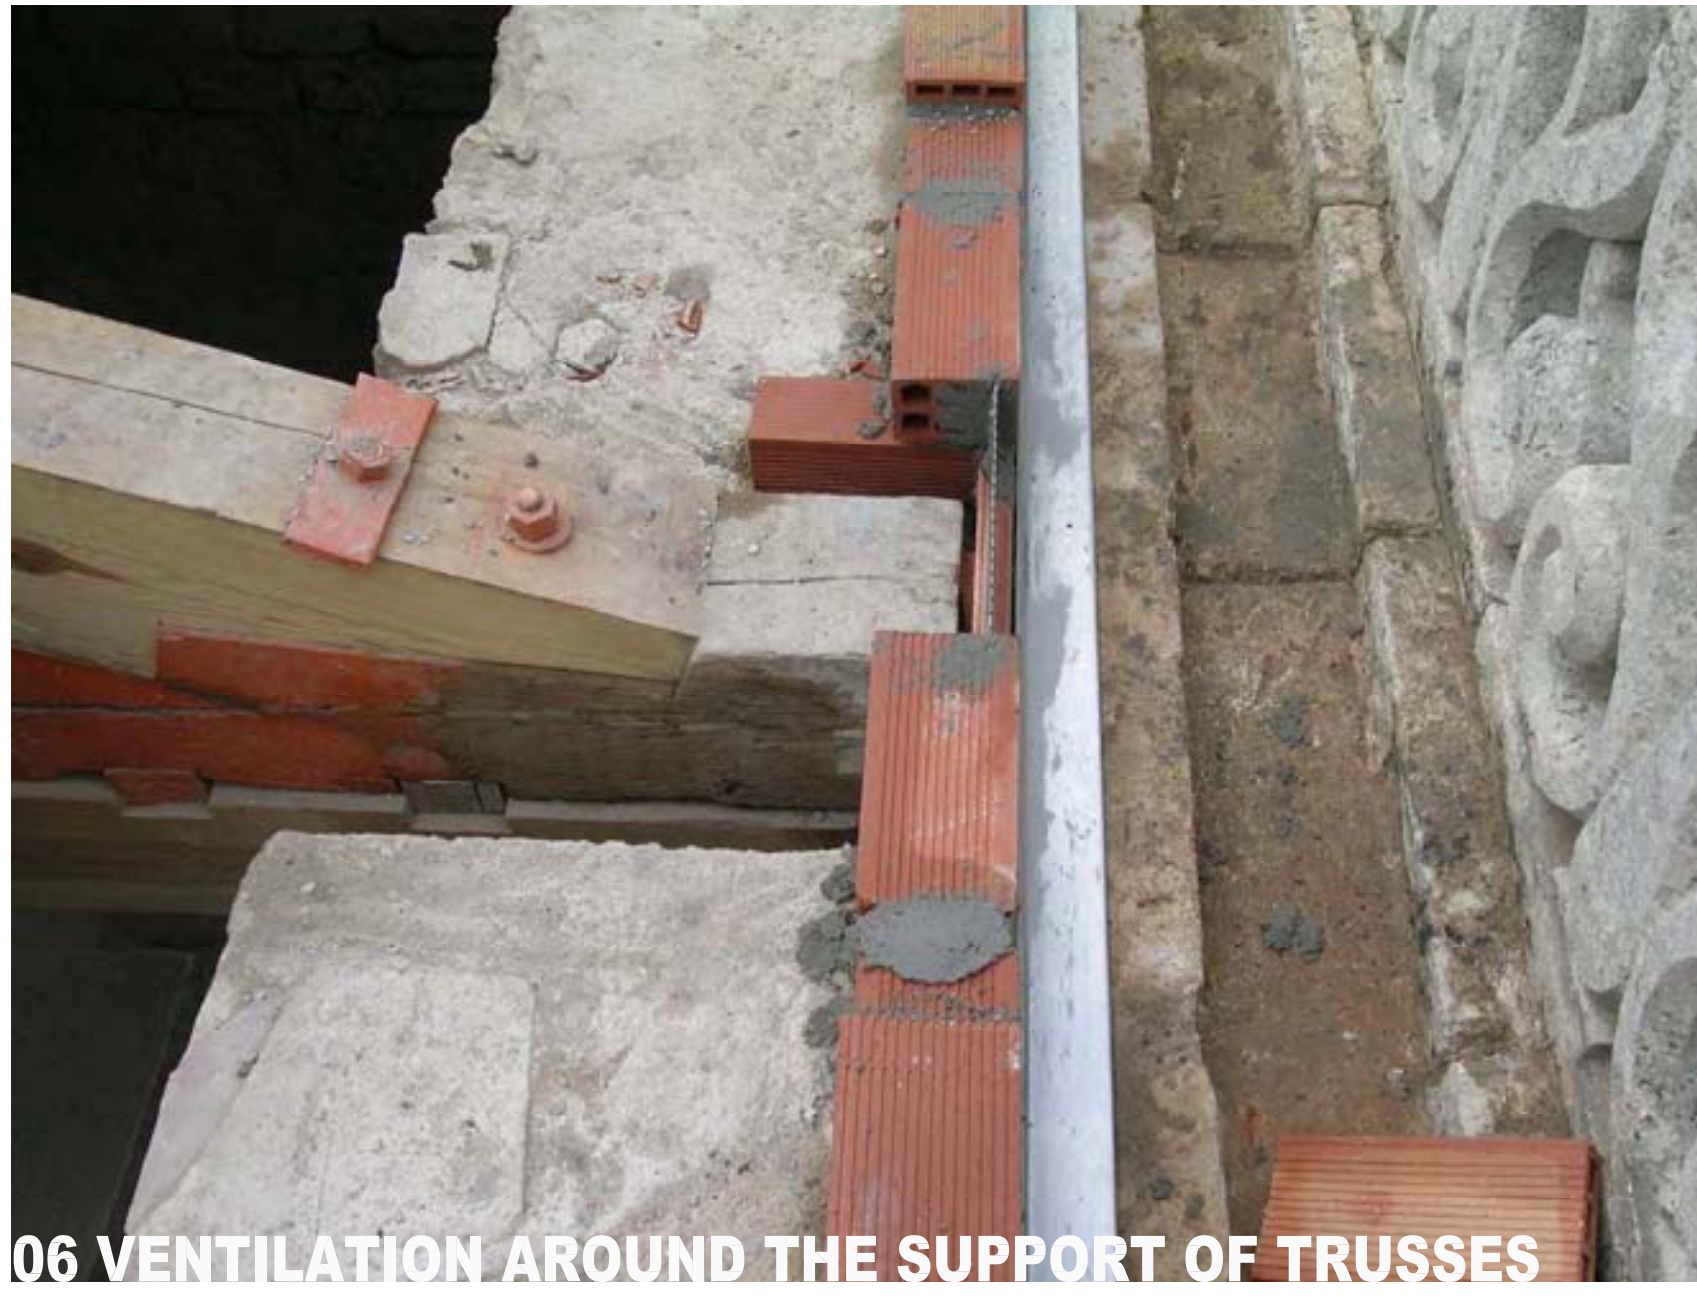
06 VENTILATION AROUND THE SUPPORT OF TRUSSES

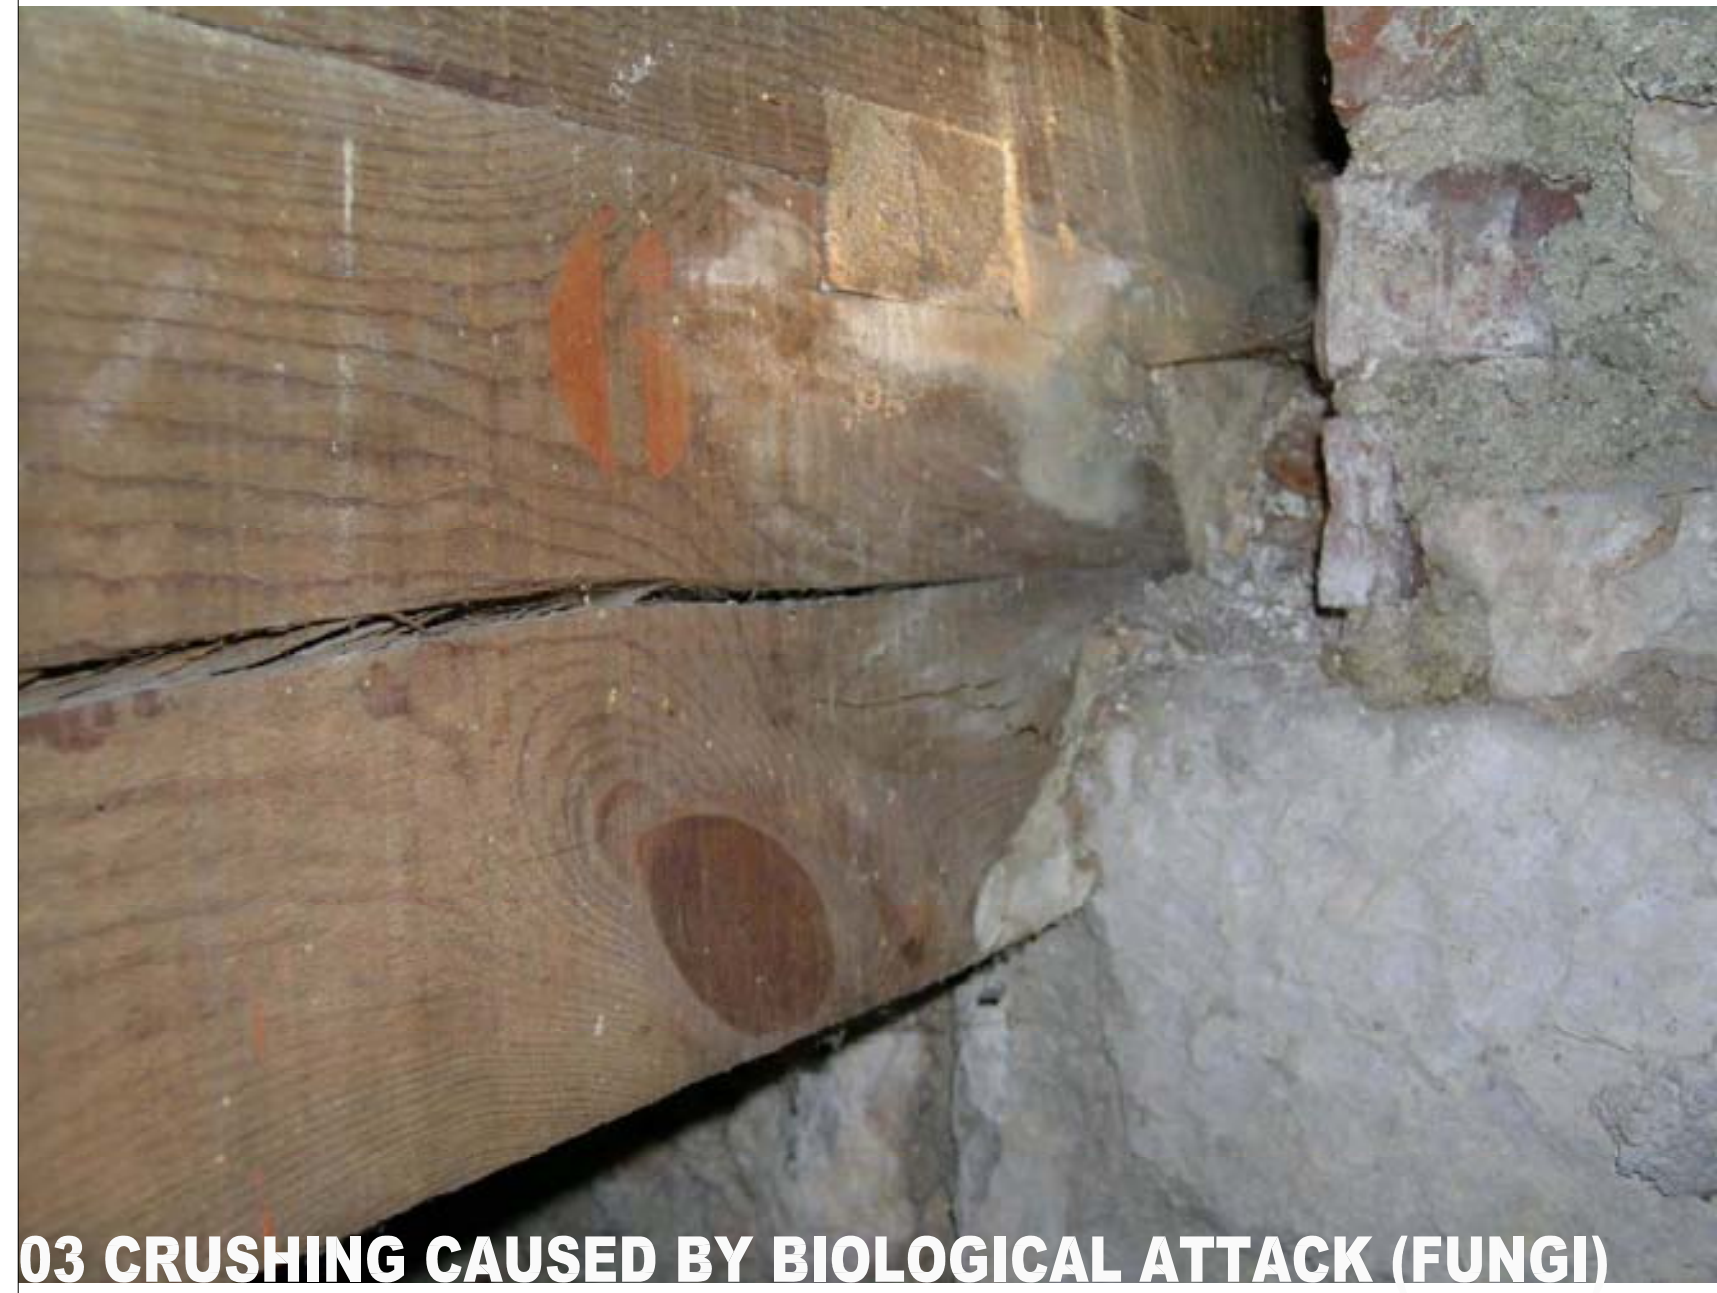
03 CRUSHING CAUSED BY BIOLOGICAL ATTACK (FUNGI)

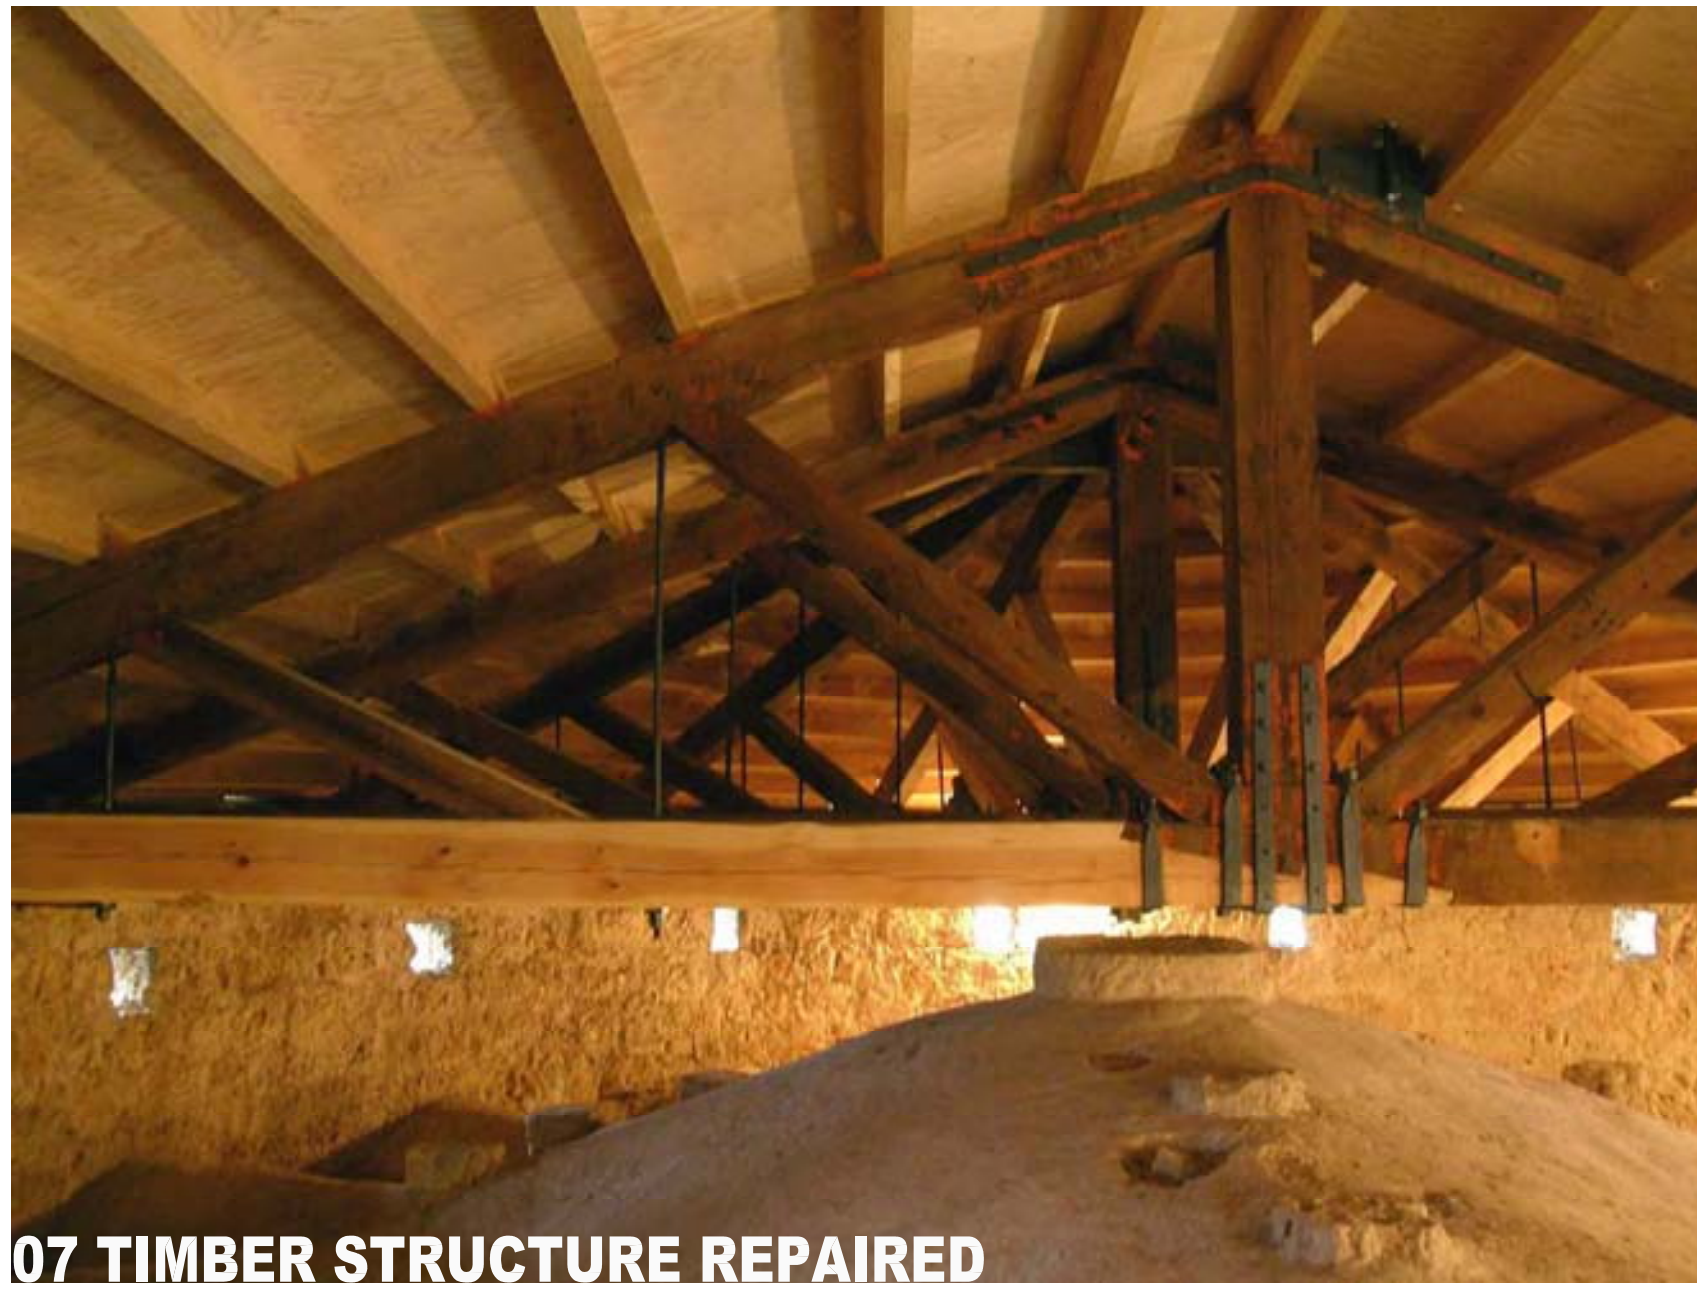
07 TIMBER STRUCTURE REPAIRED

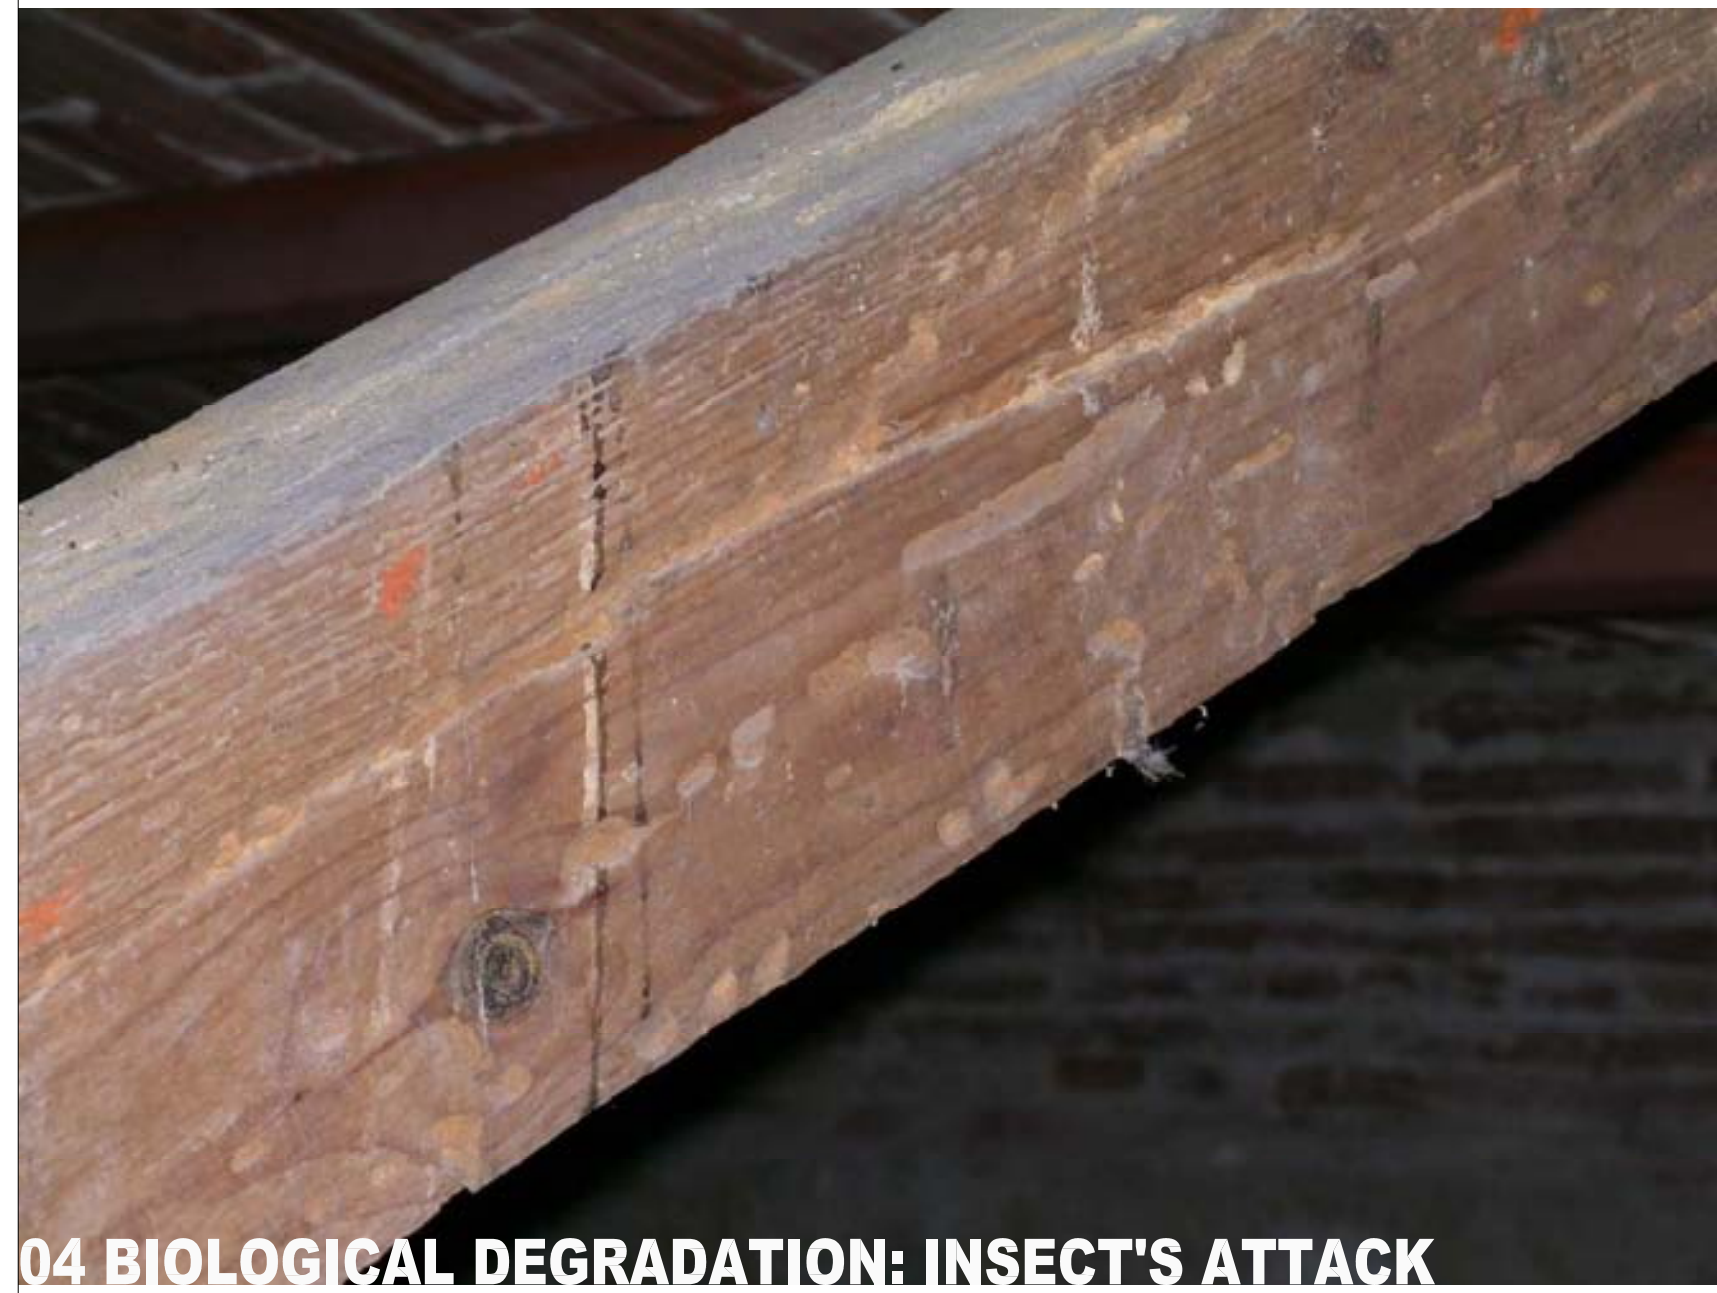
04 BIOLOGICAL DEGRADATION: INSECT'S ATTACK

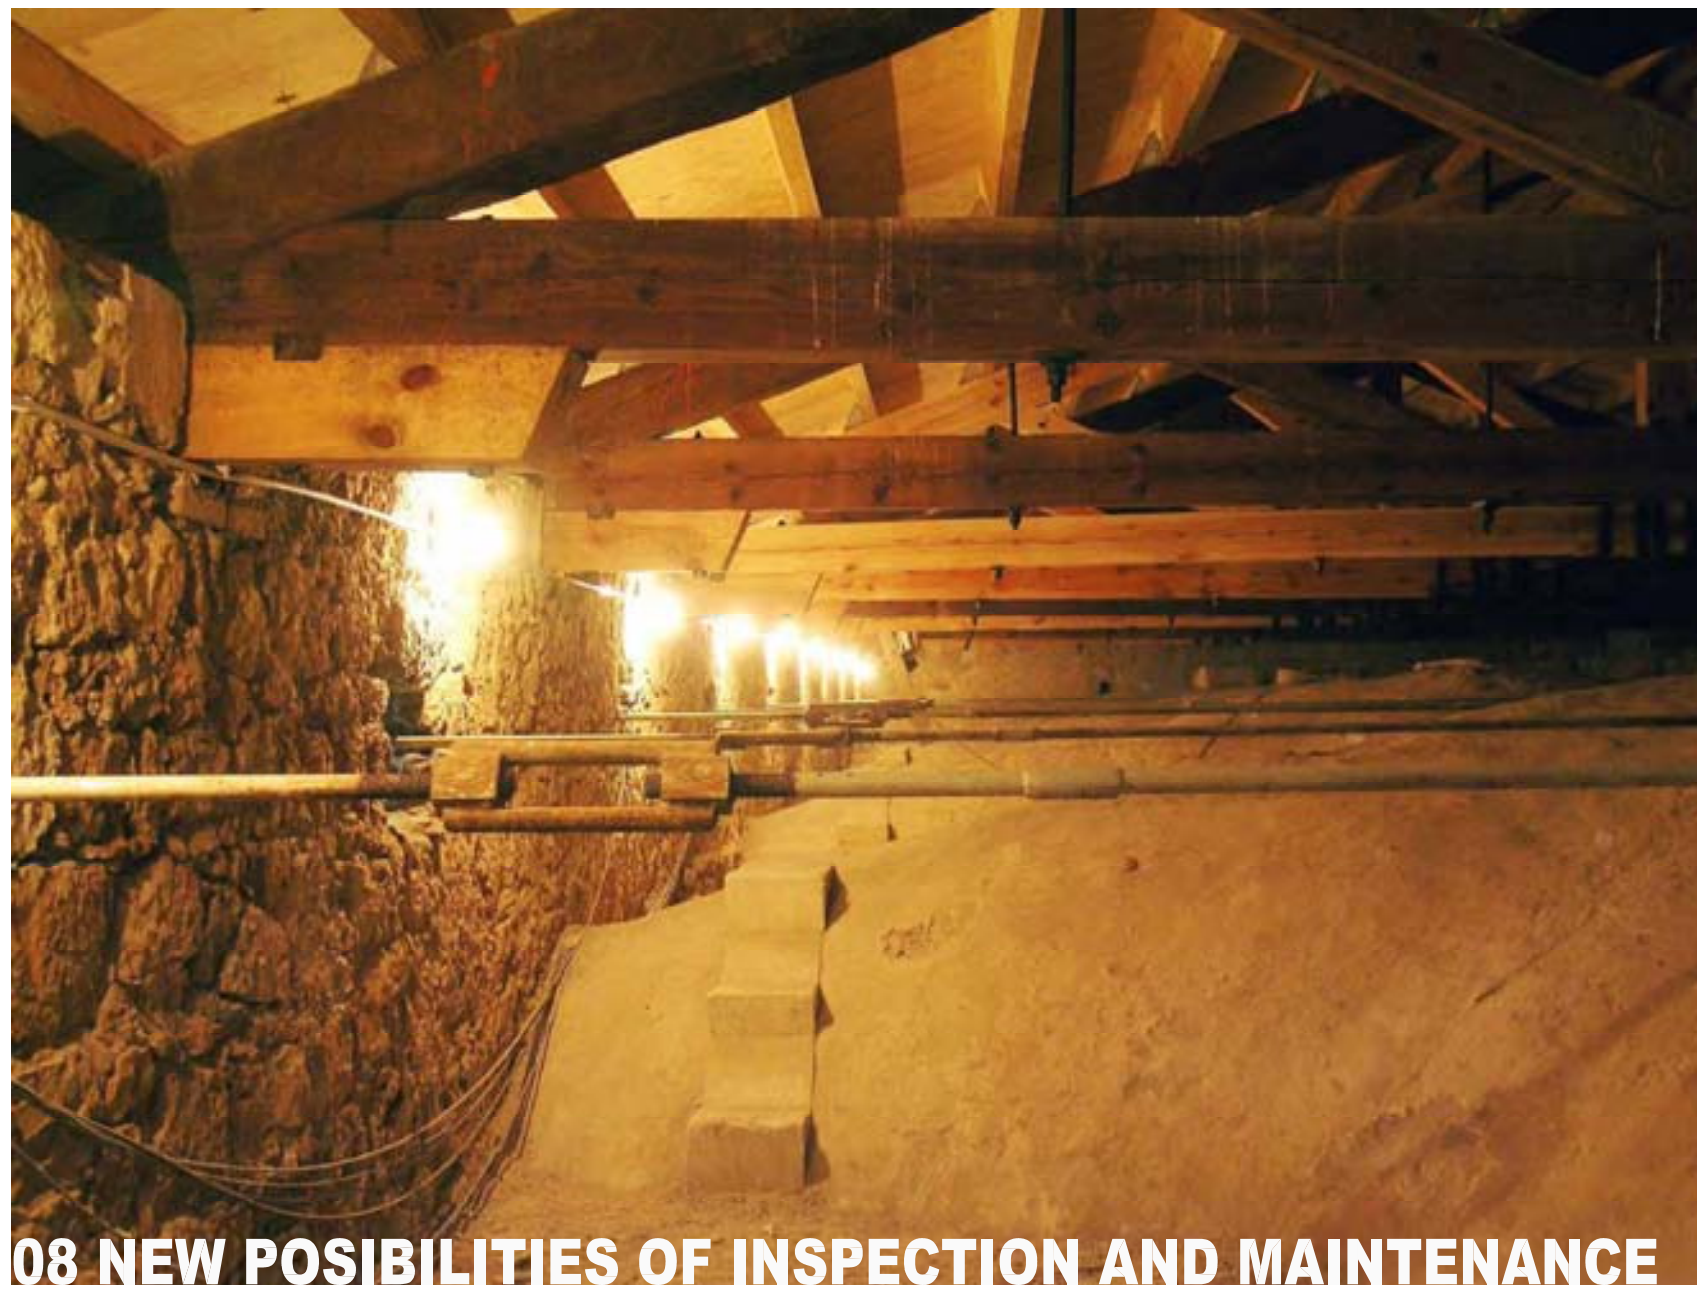
08 NEW POSSIBILITIES OF INSPECTION AND MAINTENANCE
