# Structural Condition Assessment of In-Service Wood

By Robert J. Ross, Brian K. Brashaw, and Xiping Wang

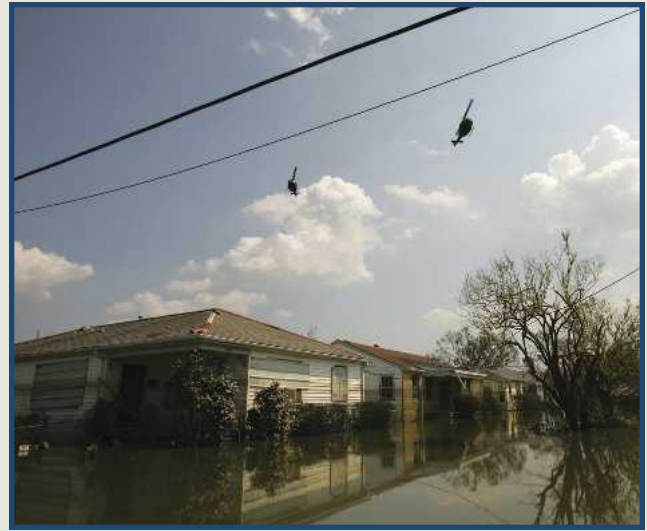
**Figure 1.** — *Flooding in the aftermath of Hurricane Katrina, which caused severe damage to structures in New Orleans.*

Wood is used extensively for both interior and exterior applications in the construction of a variety of structures (residential, agricultural, commercial, government, religious). The deterioration of an in-service wood member may result from a variety of causes during the life of a structure. It is important, therefore, to periodically assess the condition of wood used in structures to determine the extent of deterioration so that degraded members may be replaced or repaired to avoid structural failure. An assessment is especially critical for building officials in municipalities affected by catastrophic events, such as hurricanes Katrina and Rita (Fig. 1).

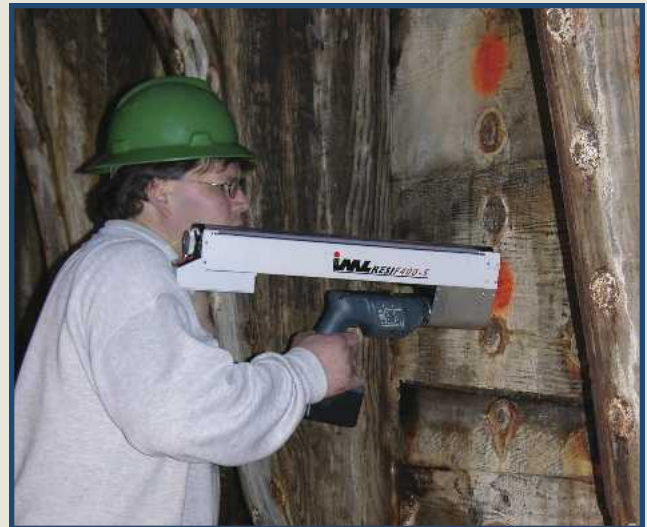
**Figure 2.** — *Field inspection using a resistance drilling device to locate areas of deterioration.*

A Resistograph tool consists of a power drill unit, a small-diameter drill bit, a paper chart recorder, and an electronic device that can be connected to the serial interface input of any standard PC. The diameter of the drill bit is typically very small, from 2 to 5 mm, so that any weakening effect of the drill hole on the wood cross section is negligible.

drilling can help inspectors to further define the decay's extent and limits (Fig. 2).

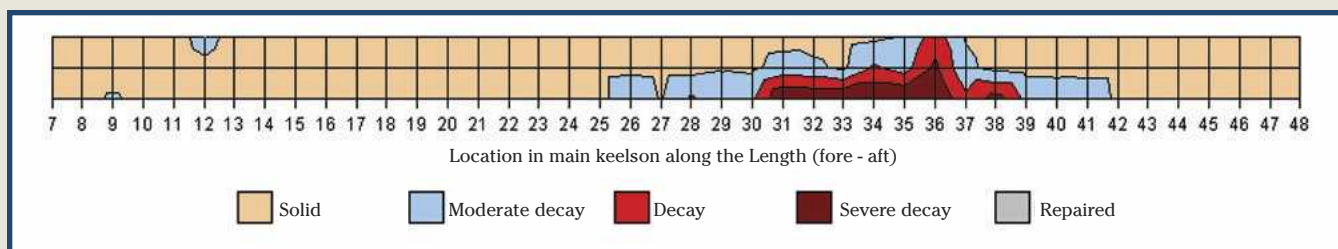
**Figure 3. — Results obtained from a typical stress wave scan of an in-service wood member.**

Stress wave transmission techniques are used in decay detection in a variety of wood structures. The concept of detecting decay using this method is that stress wave propagation is sensitive to the presence of degradation in wood. In general terms, a stress wave travels faster through sound and high quality wood than it does through wood that is deteriorated or of low quality. The time-of-flight (or transmission time) of the stress wave is typically used as a predictor of the physical conditions inside the wood. By measuring the time-of-flight of a stress wave through a wood member perpendicular to the grain, the internal condition of the member can be determined.

Stress wave transmission times on a per-length basis for various wood species have been given in the *Wood and Timber Condition Assessment Manual*. Stress wave transmission times are shortest along the grain (with the fiber) and longest across the grain (perpendicular to the fiber). For Douglas-fir and southern pine, stress wave transmission time parallel to the fiber is approximately 200  $\mu\text{s}/\text{m}$  (60  $\mu\text{s}/\text{ft}$ ). Stress wave transmission time perpendicular to the fiber ranges from 850 to 1000  $\mu\text{s}/\text{m}$  (259 to 305  $\mu\text{s}/\text{ft}$ ). When a stress wave propagation method is used to detect localized decay in timbers, measurements should be made in transverse paths (perpendicular to the grain). Parallel-to-grain travel paths (longitudinal direction) can bypass regions of decay and therefore are not effective. Figures 3 and 4 show the testing results and the use of stress wave/ultrasound testing equipment to detect wood decay.

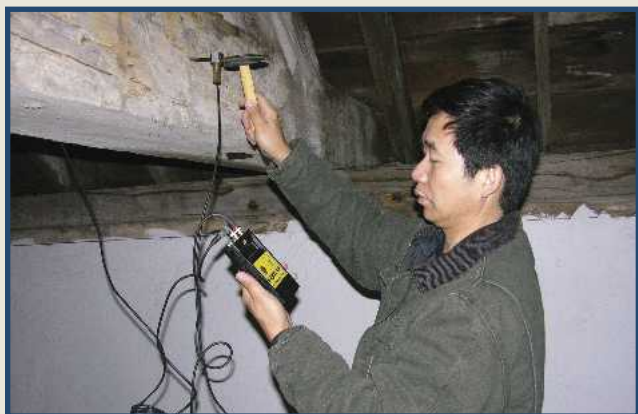
**Figure 4. — Field inspection using stress wave/ultrasound equipment.**

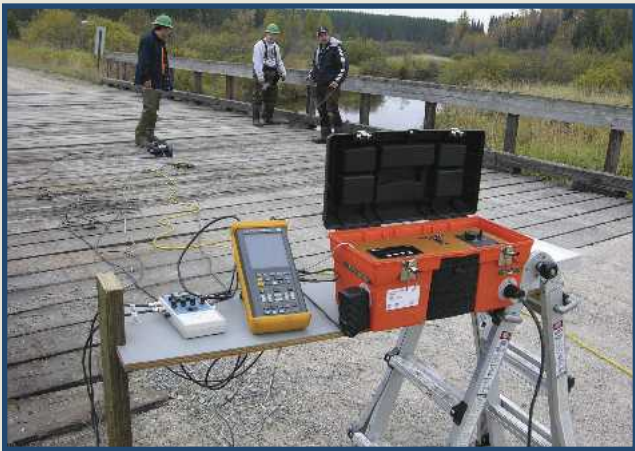
**Figure 9. — Testing a timber bridge using vibration techniques.**

The methods currently used to assess the condition of wood in service are based on techniques that evaluate individual members or small areas within a wood member. Recently, an extensive series of experiments was conducted to examine the feasibility of testing, in-place, entire structural wood systems. The results to date have shown that it may be possible to assess the in-place stiffness of some types of structural systems (e.g., short-span timber bridges and floor systems within buildings) using vibration techniques (Fig. 9).
