ON SITE DIAGNOSIS AND ASSESSMENT OF THE NAVE TIMBER STRUCTURE OF SEGOVIA CATHEDRAL (SPAIN) USING NON DESTRUCTIVE TECHNIQUES

Basterra, L.A. (1), López, G. (1), Ramón-Cueto, G. (1), Acuña, L. (2) and Casado, M. (2)

Abstract

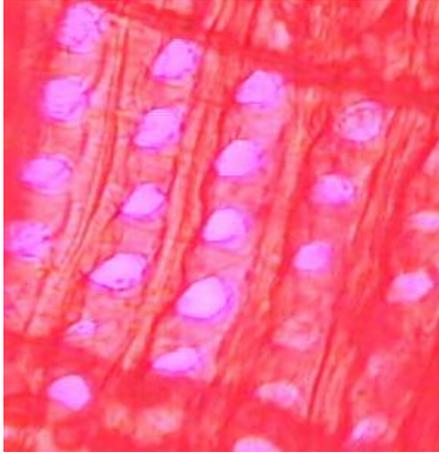
Figure 14. Microscopic image of rafter

In this case, all samples collected from each of the structural elements of the roof correspond to the species of *Pinus sylvestris*. This is corroborated in the historic report we mentioned before, as there are references to the wood coming from the region of Mount Valsain and that historically *Pinus sylvestris* had been the characteristic species in the region.
