SACoMaTiS 2008

International RILEM Conference

ON SITE DIAGNOSIS AND ASSESSMENT OF THE NAVE TIMBER STRUCTURE OF SEGOVIA CATHEDRAL (SPAIN) USING NON DESTRUCTIVE TECHNIQUES

Basterra, L.A. (1), López, G. (1), Ramón-Cueto, G. (1), Acuña, L. (2) and Casado, M. (2)

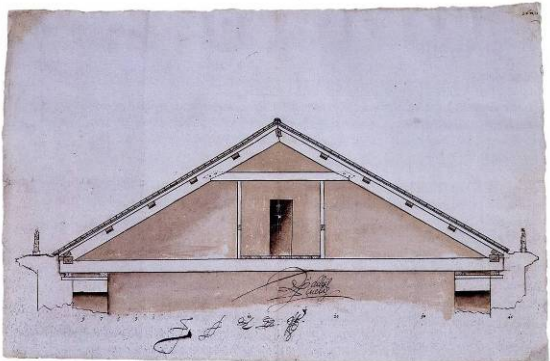
Figure 4. Central nave truss according to Pedro Brizuela (Segovia, 1555, 1631).

- A general inclination or slope of the trusses towards the east. There has been an attempt to resolve this tendency by placing a cross brace between the collar brace and the rafters ties. This solution is inadequate and pushes down on the collar braces causing torsion and horizontal bending.

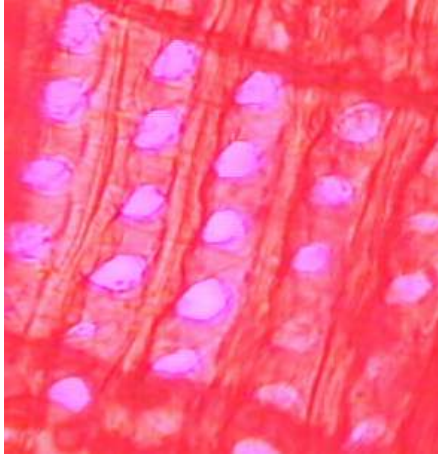
In this case, all samples collected from each of the structural elements of the roof correspond to the species of *Pinus sylvestris*. This is corroborated in the historic report we mentioned before, as there are references to the wood coming from the region of Mount Valsain and that historically *Pinus sylvestris* had been the characteristic species in the region.

Figure 14. Microscopic image of rafter

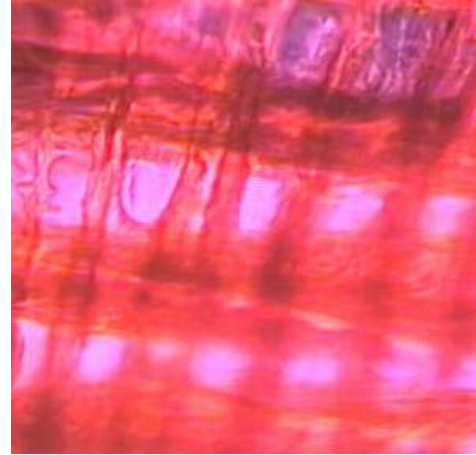
Figure 15. Microscopic image of rafter 8-South.

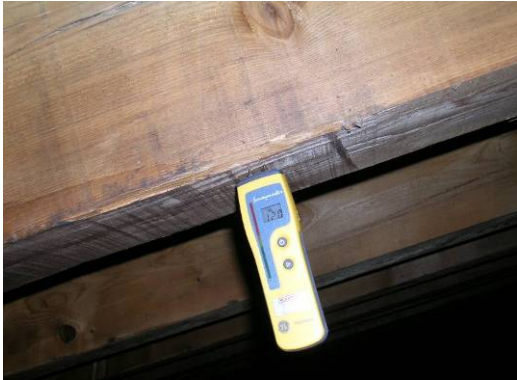
In our case, the moisture content of the wood tested had an average humidity value of between 10 and 15%, which is considered normal for timber in a roof structure. However, there are areas where, due to rainwater leaks, high moisture content, in excess of 17%, was found. These high readings can be compared directly with the thermographic images taken, which reflect the distribution of humidity in each timber element.

Figure 16. Humidity reading with electric xilohigrometer.

As a general rule, all humid or wet areas should be eliminated. The accumulated debris, which makes adequate ventilation impossible, should also be removed.

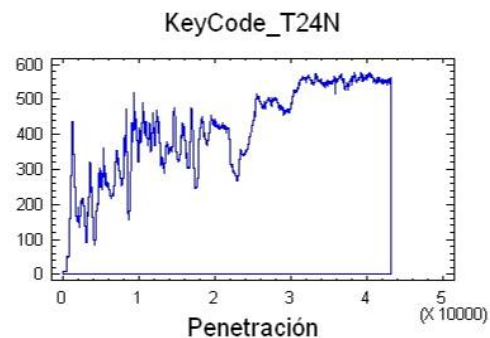
Figure 19. Resistogram data.

The drilling kit used in these tests was the German made RINN-TECH RESISTO-GRAPH® XB-3450-S Professional model. Data were recorded graphically in its memory, and a small printer was used, which printed the resistographic profiles at 1:1 scale. Relating graphically employed force (% amplitude) per length unit. Analyses were carried out only in areas inaccessible by other techniques.
